NBSIR 76-1182

The Thermal Performance of a Two-Bedroom Mobile Home

Final Report

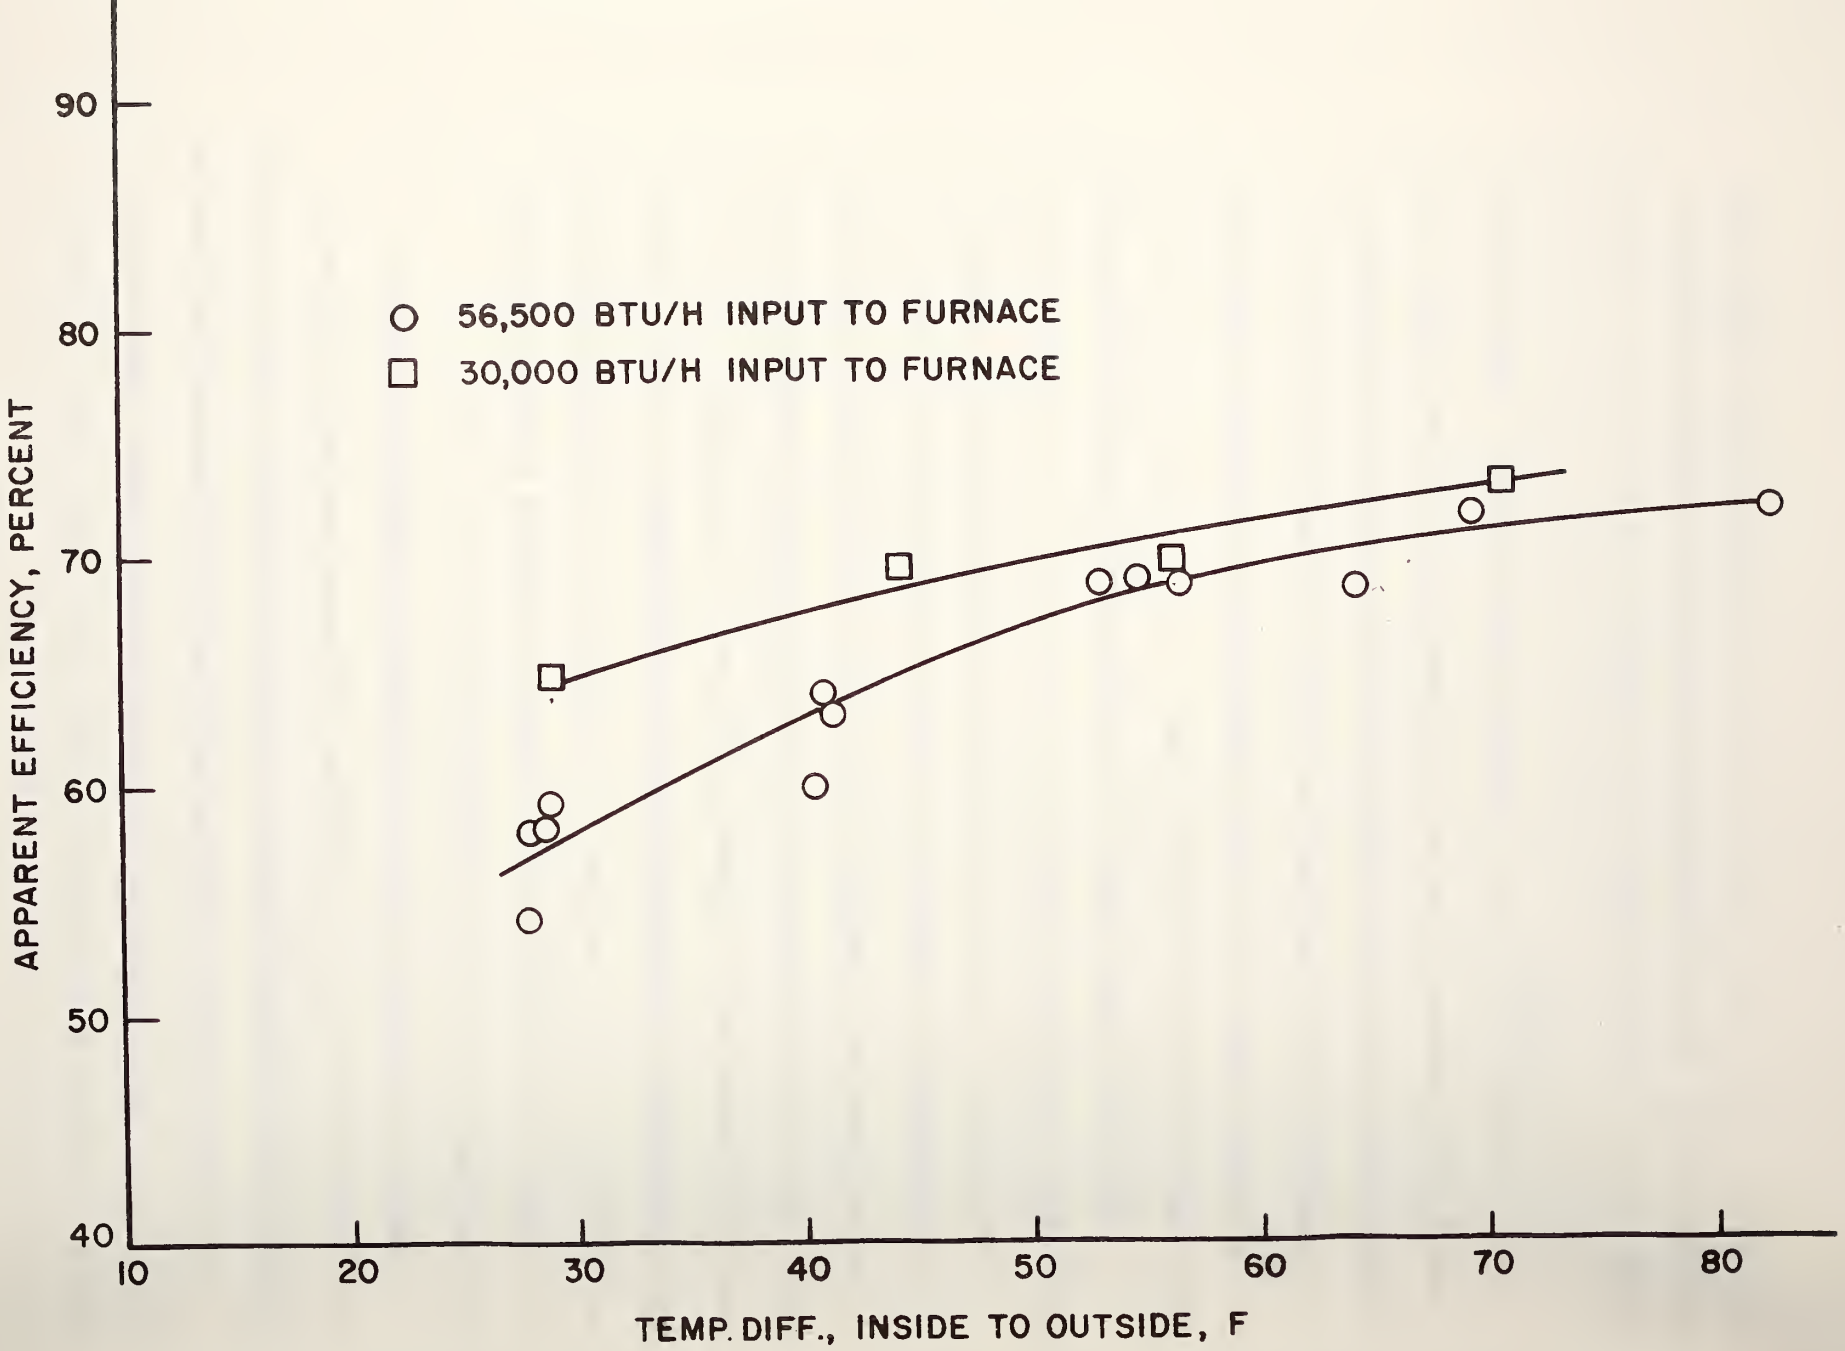
Figure 16. Apparent thermal efficiency of the original and modified furnace vs. inside-to outside temperature difference.

The reduction in energy consumption can be attributed to the increased percent on-time shown in figure 17, resulting in decreased time for off-cycle stack losses. The apparent efficiencies shown in figure 16 were determined by comparing the gross gas furnace input to the electrical input under the same test conditions, assuming the electric furnace to be 100 percent efficient. At a temperature difference of 70 F, both gas furnaces approach their continuous running efficiencies. At 30 F temperature difference, the difference in efficiency is greater than 10 percent. These low-load operating conditions are common during the heating season.

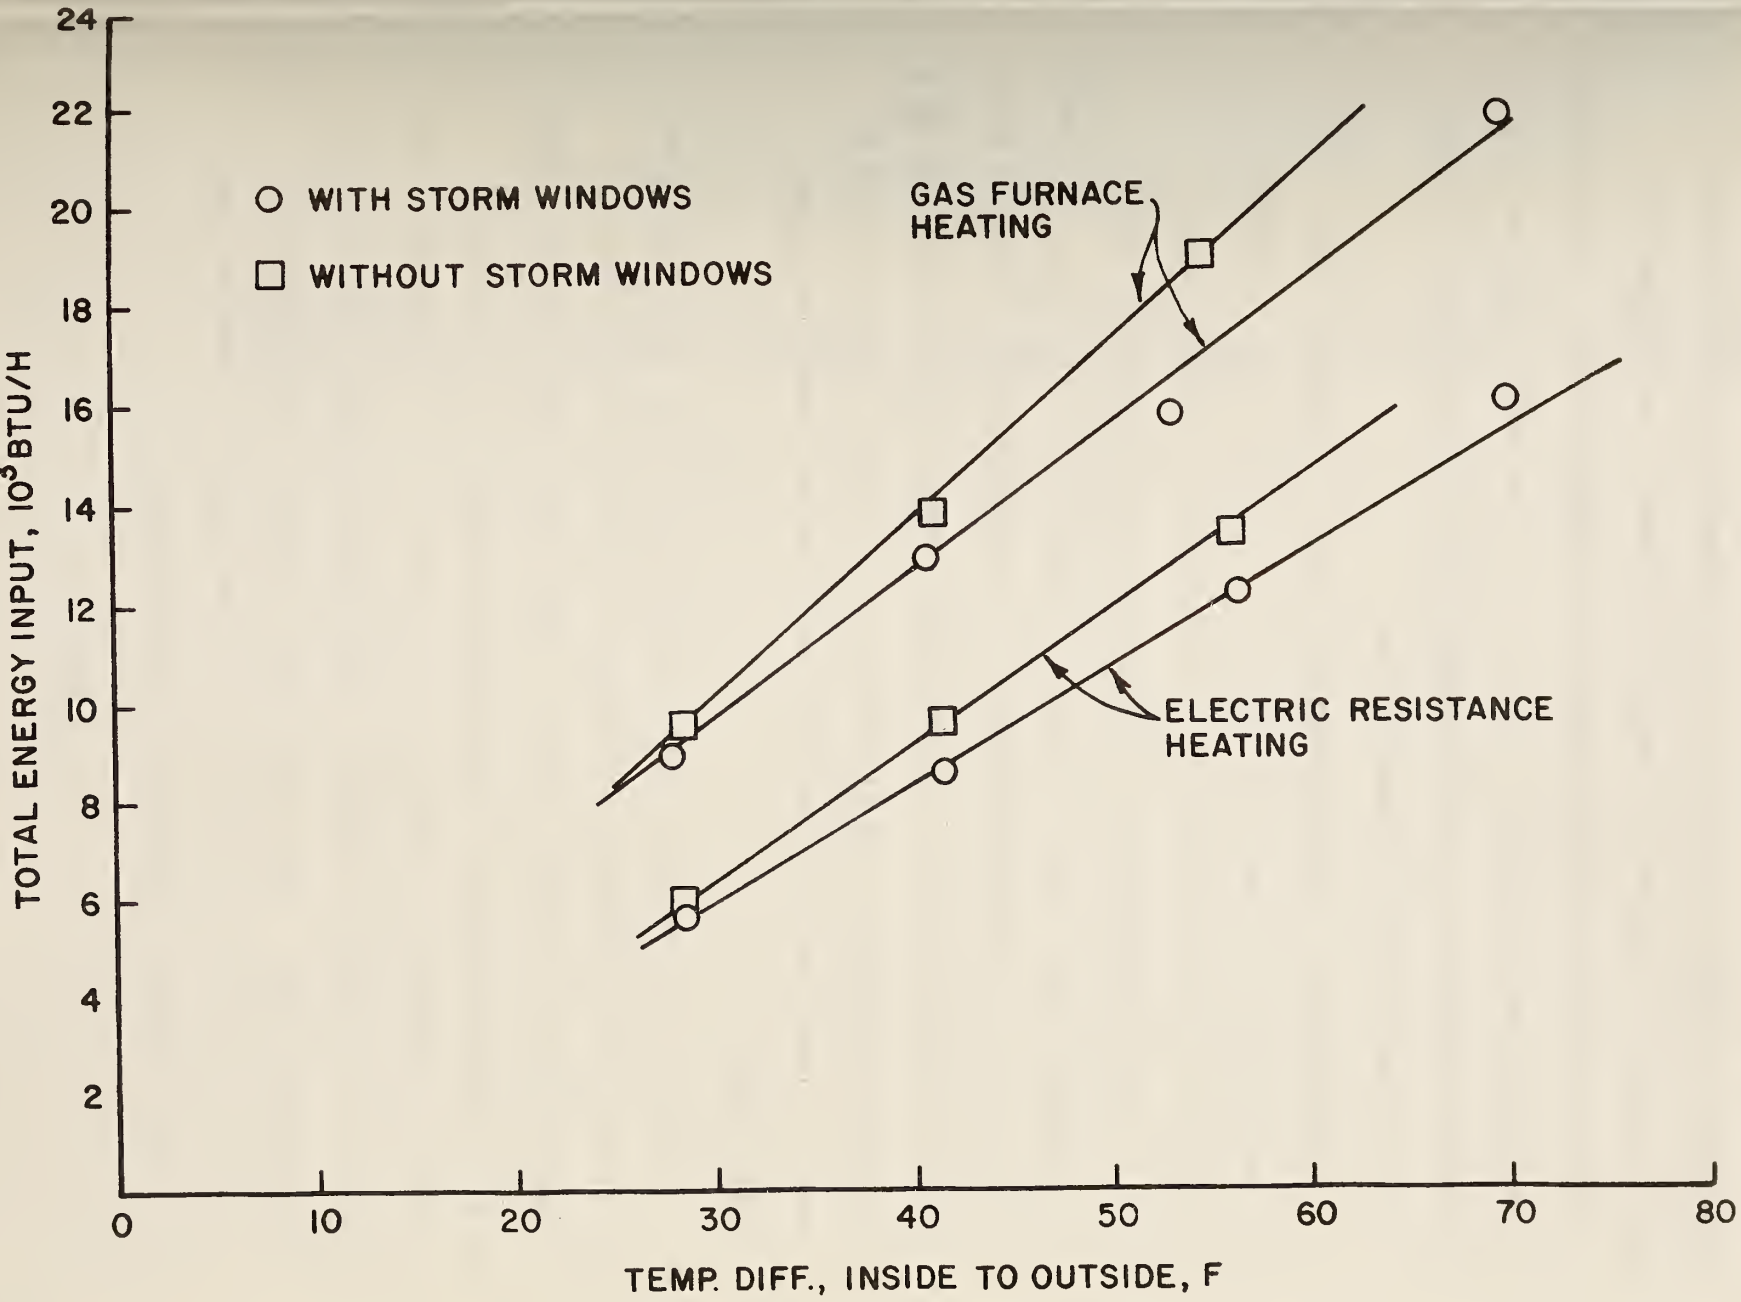
Figure 19. Total energy input to mobile home vs. inside-to-outside temperature difference.

efficiency) are shown for each of the steady-state tests. It can be seen that the energy consumption rate was significantly lower for the modified furnace than for the original-equipment furnace, especially at the lower inside-to-outside temperature differences where the effect of oversizing is more pronounced. This is true even though infiltration rates are assumed to be slightly higher with the smaller furnace because of the increased furnace blower on-time.

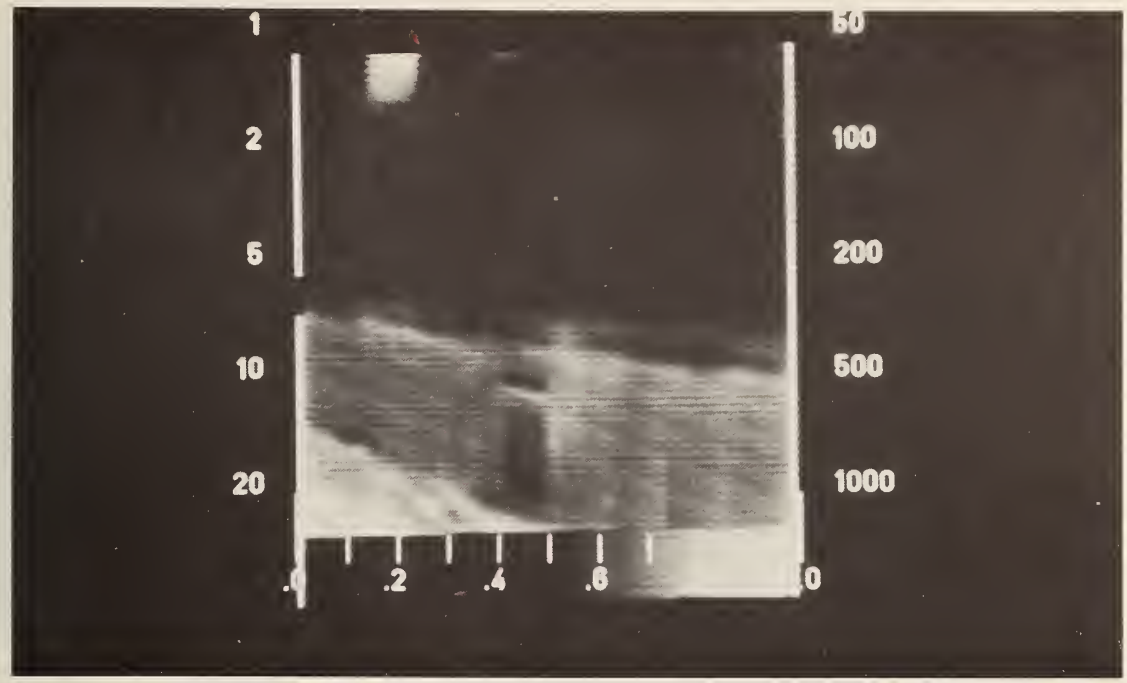
Figure 23. Angular thermograph of exterior sidewall of mobile home. Dark area (colder) is the aluminum wall surface. Lighter area (warmer) below is the skirting at base of mobile home , and white area in lower left is ground surface. Dark area found in skirting is an air vent (refer to figure 14).

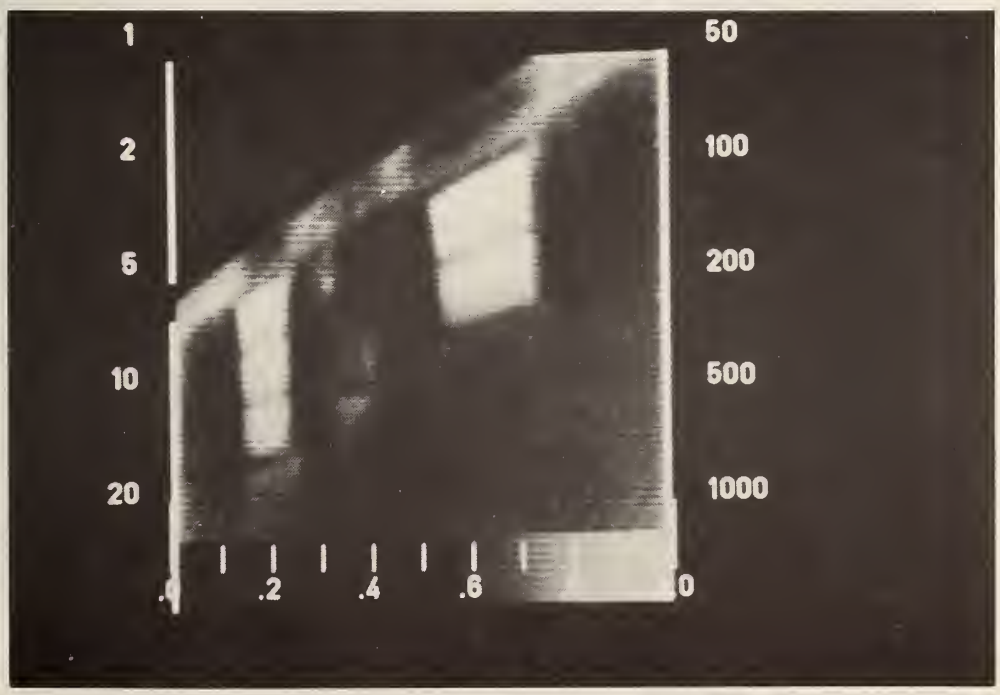
Figure 24. Warmer horizontal aluminum trim at wall roof juncture.

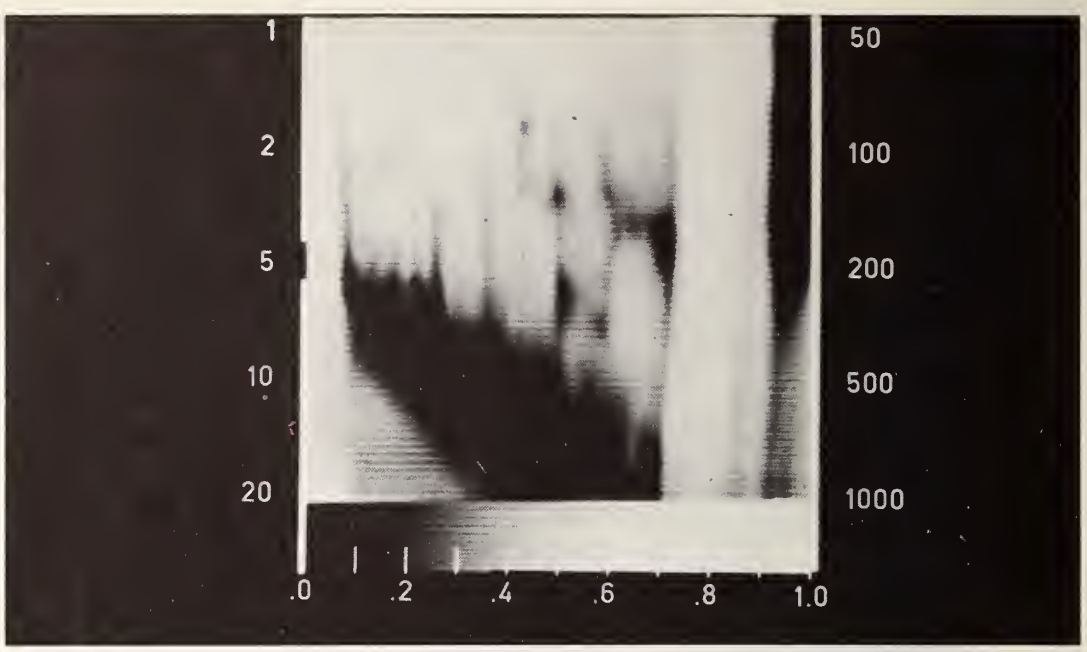
Figure 25. Wall along hallway looking from kitchen area. Walls are colder at the base of the wall. Cold streaks occur randomly along wall.

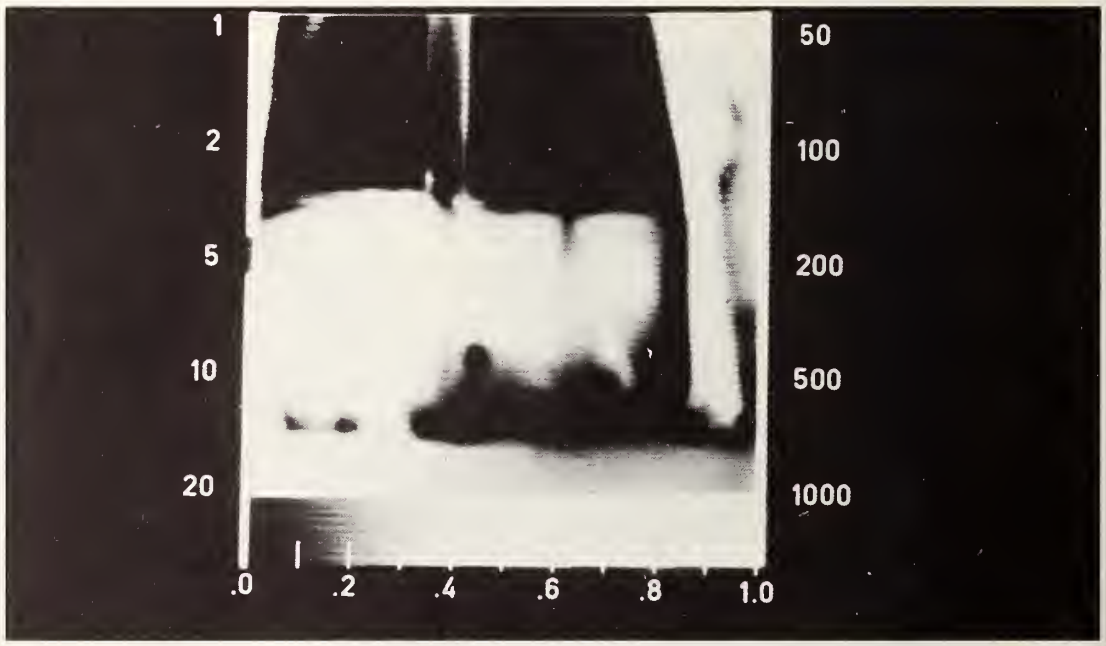
Figure 26. Wall at base of double living room window. Warm air register at lower left is warming the wall surface under left window.

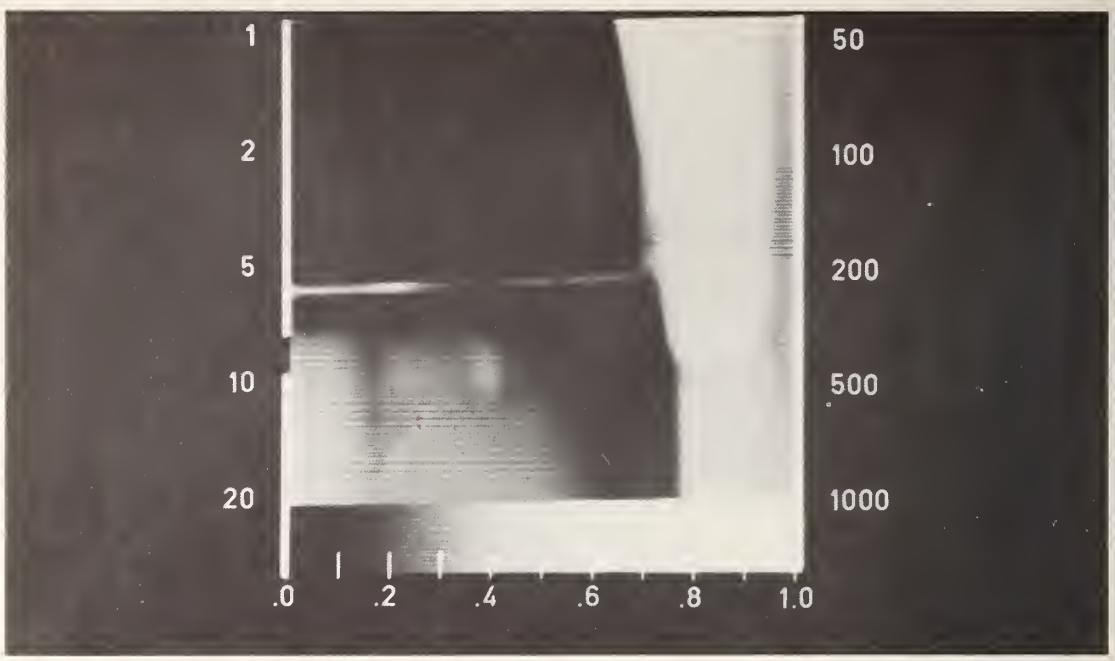
warming the wall surface. The general thermographic observations also revealed some air infiltration locations. Figure 27 shows a cold (dark) area under a window where outside air is leaking in around the window framing. The wall/floor corner shown in figure 28 is obviously very cold. Closer observations at this location revealed an air leak at the wall/floor junction resulting in an interior surface temperature of 29 F in the corner (inside 72 F, outside 0 F).

Figure 27. Window with warm curtain (light area) on right side. Dark (cold) area on wall under window is due to perceptible cold air leaking into mobile home.

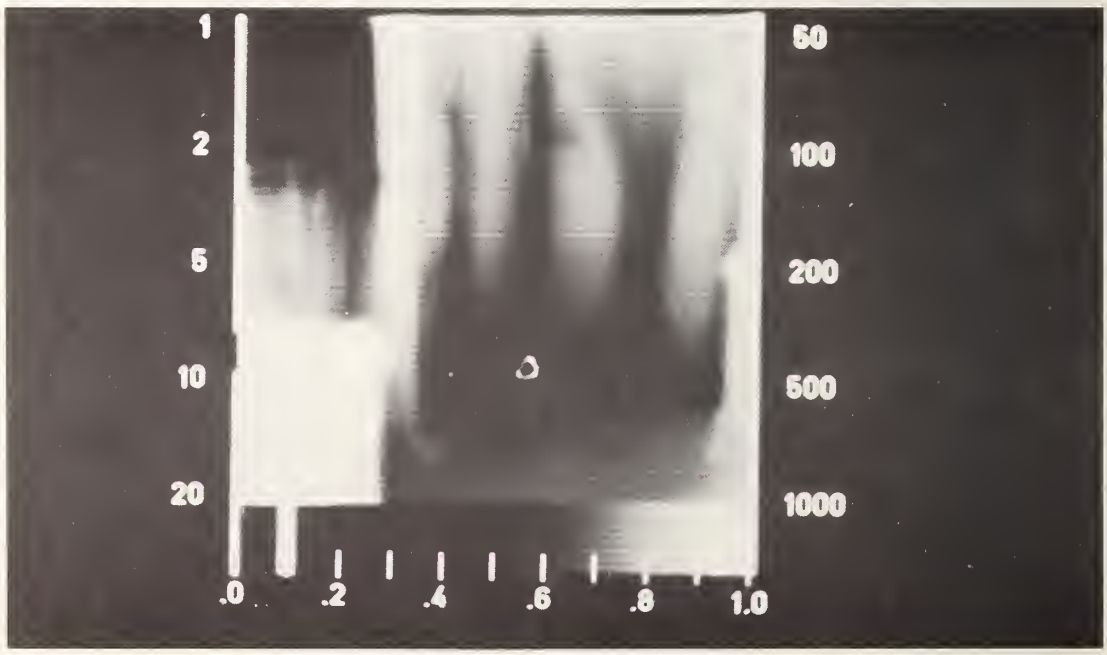
Figure 28. Living room wall/wall/floor corner. Perceptible air leak in corner created very cold spot, out of camera range. Light area in lower left is couch.

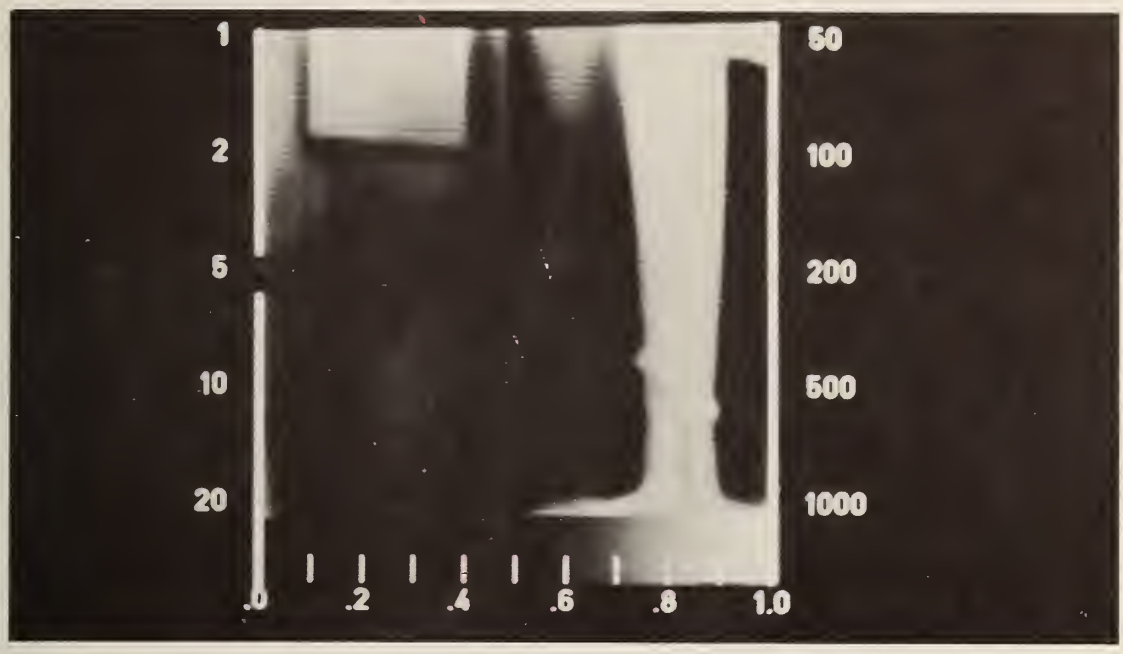
From these observations, it was hypothesized that cold air must be in contact with the interior wood paneling. This early hypothesis was later supported when it was observed that the cold patterns on the wall correspond directly with locations where the insulation was not in contact with the wood paneling, leaving an air channel between the insulation and the paneling.

Figure 29. Wall area to left of living-room side-wall window. Picture on wall at upper left, draperies along window on right side of picture. Dark areas are cold. Note wall studs showing through in upper center. Location as shown on figure 30.

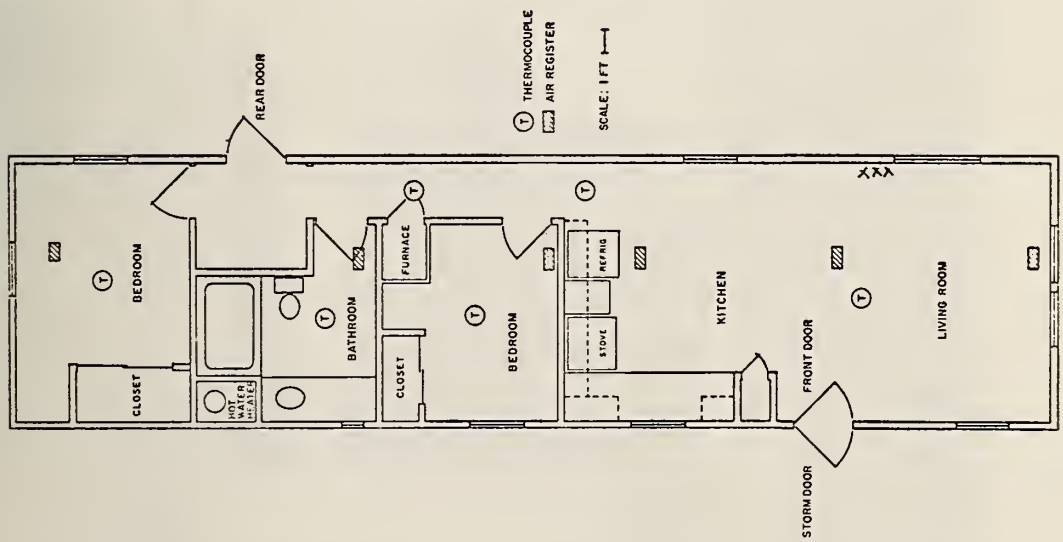
Figure 30. Location of thermographic investigation of wall performance denoted by X.

To test this hypothesis and evaluate various corrective techniques, a series of changes were made in the wall construction and the resulting thermal profiles were observed. All of these changes were made in one location as identified in figure 30.

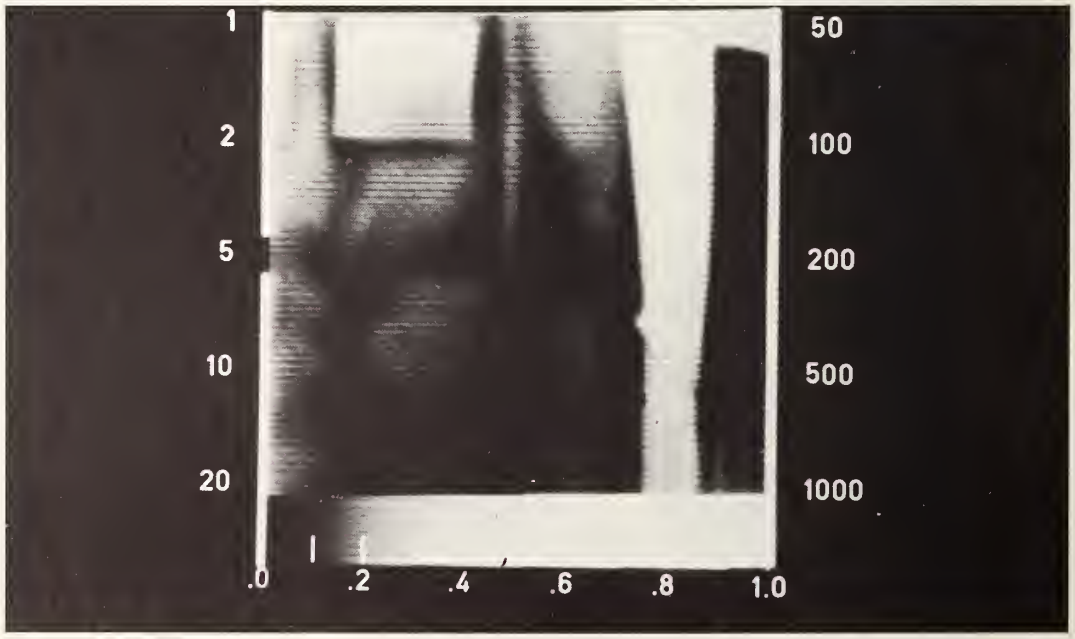
Figure 32. Thermograph of wall test area after sealing outside of insulation cavity with polyethylene film.

cavity, pass under the insulation, rise between the insulation and interior paneling and then pass to the outside over the insulation at the top. The exterior aluminum paneling allows more or less free passage of outdoor air into and out of the wall cavity outside of the insulation.

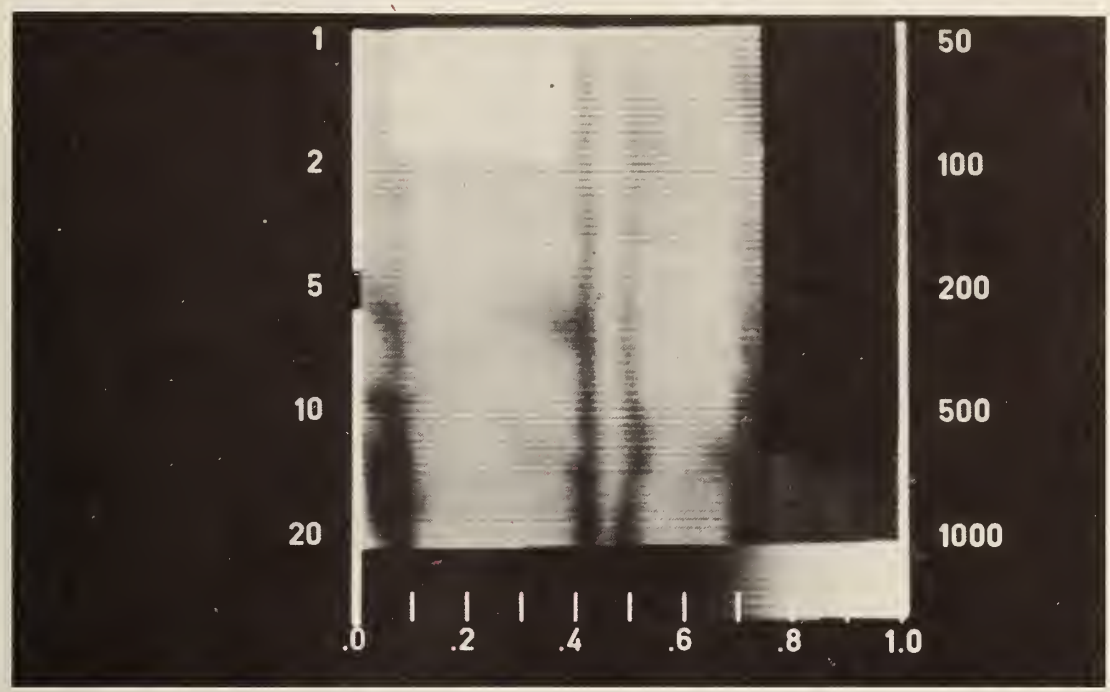
After it was determined that sealing the outside surface of the wall would not prevent the occurrence of cold patterns on the inside surface, it was reasoned that cold air could be circulating in a closed loop around the insulation within the stud cavity, without direct air leakage to the outside, effectively siphoning heat to the outside. This theory was tested by taping the inside vapor barrier of the insulation to the adjacent wood studs (see fig. 34). This figure also shows the taped lines outlining areas of the insulation which were in contact with the back surface of the wood paneling. Those areas in contact had warmer inside surface temperatures, supporting the theory that air movement within the stud space was causing the cold streaking on the inside wall surface.

Figure 37. Interior thermograph after installing R-11 batt with friction fit. Note studs and cold streak caused by wrinkle in friction fit batt in narrow cavity.

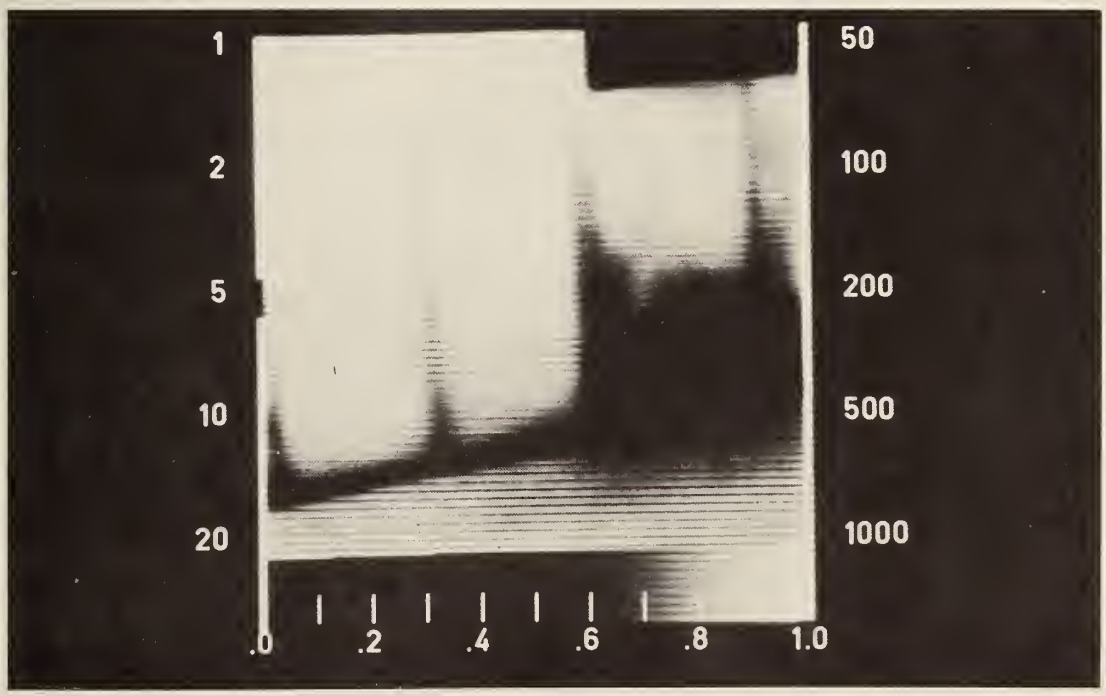
Figure 38. Interior thermograph with R-11 batts installed as shown in figure 36.

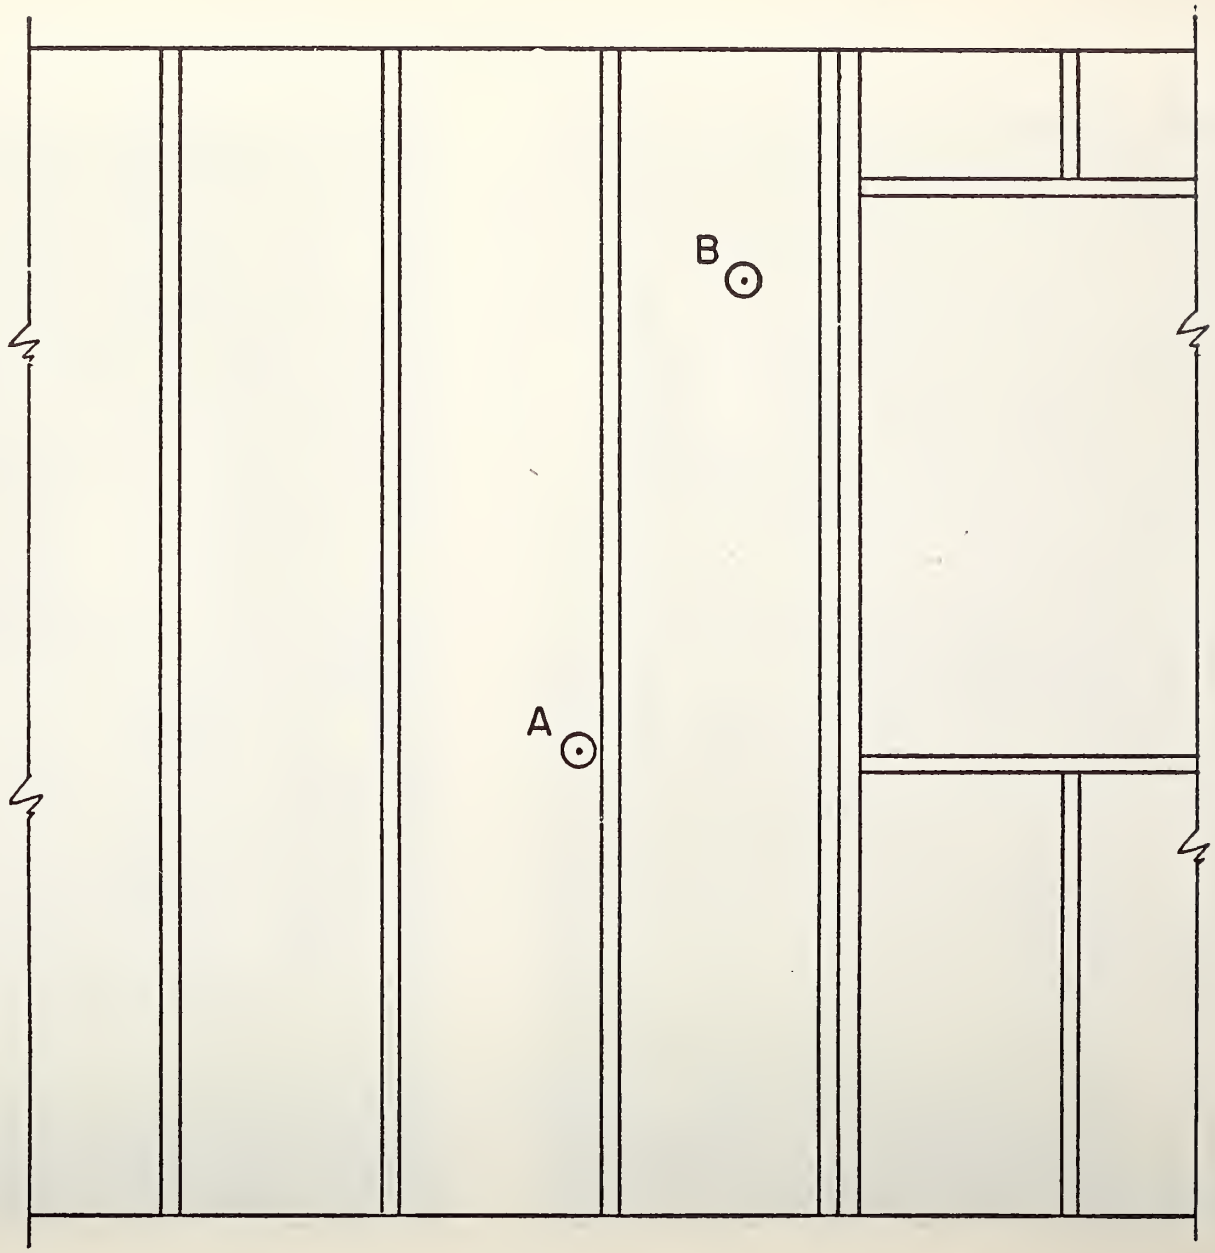
Figure 39 . Thermocouple locations on inside of wall paneling. Temperature readings shown on Table 4.

In both cases, thermographic and thermocouple observations revealed that the cold streaks were substantially eliminated with full batts. Without neat, mechanically-attached placement, some streaks did occur along the studs where the insulation was wrinkled due to stuffing the stapleing flanges of the vapor barrier into the stud space, allowing air passage (see figure 37). With neat attachment, cold streaking was eliminated and surface temperatures were very even, as shown in figure 38 . As changes were made in the insulating system, inside-surface temperatures were recorded with the thermocouples located at A and B as shown in figure 39 . These temperatures are shown in table 4.

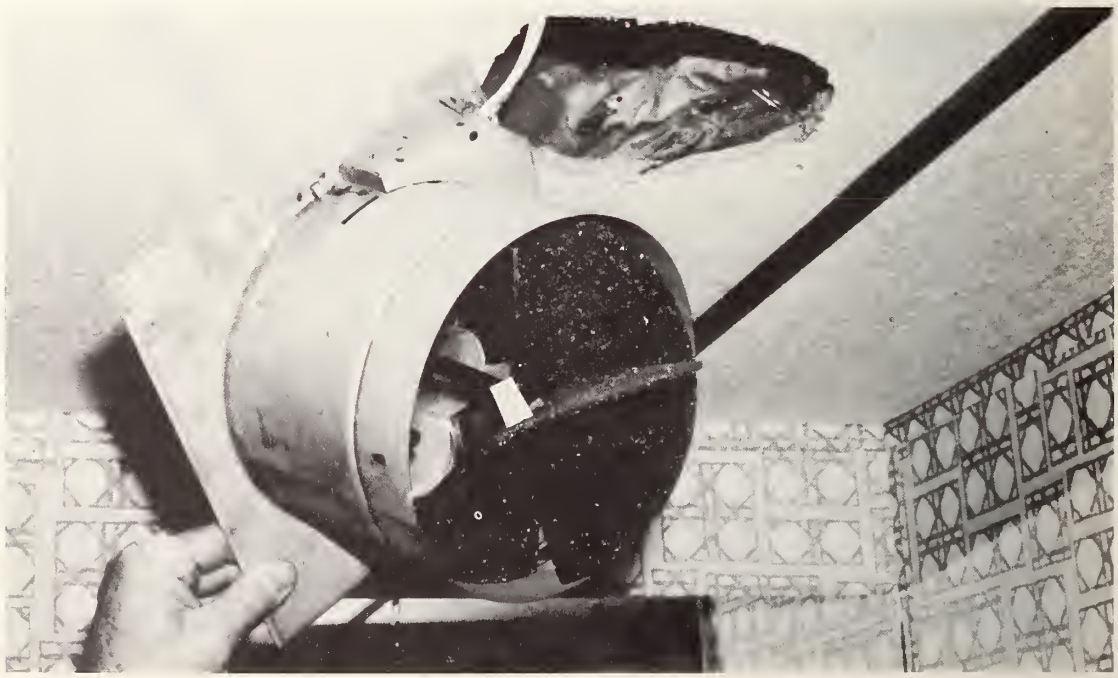
Figure 48. Bathroom exhaust fan with foam plastic backflow sealing flaps.

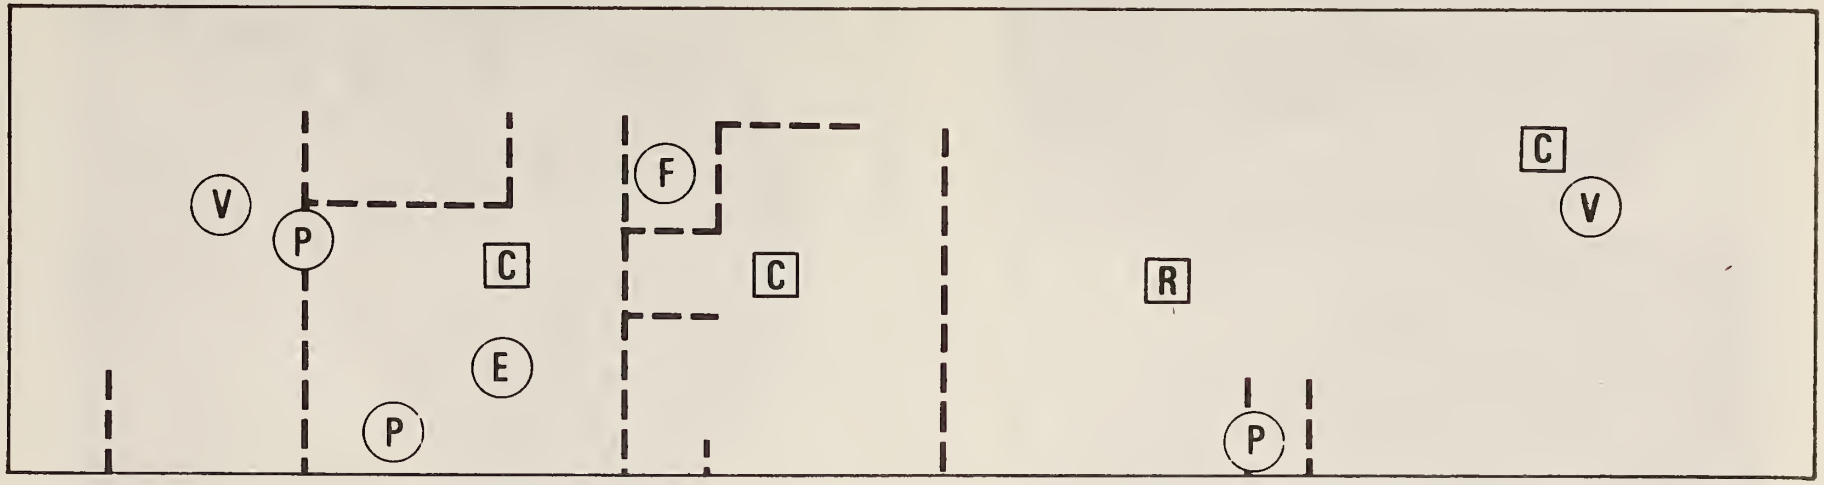
Figure 49.. **PLAN VIEW OF ROOF**

Roof test cut No. 2 was made far removed from the furnace flue, in an area where the cracking noise created by roof-top traffic was not predominant. At this location, very little frost appeared between the metal roof and the sheathing. This frost consisted of fine frost lines on the under surface of the metal with no observable frost on the top side of the sheathing. A thin film of frost was observed on the underside of the sheathing (more than on the underside of the metal roofing). The glass-fiber-batt roof insulation appeared dry at this location.

Roof test cut No. 3 was made near the bathroom exhaust vent stack. The previously discussed cracking noises were very predominant in this general area. Frost was observed between the metal and the sheathing (more frost at this

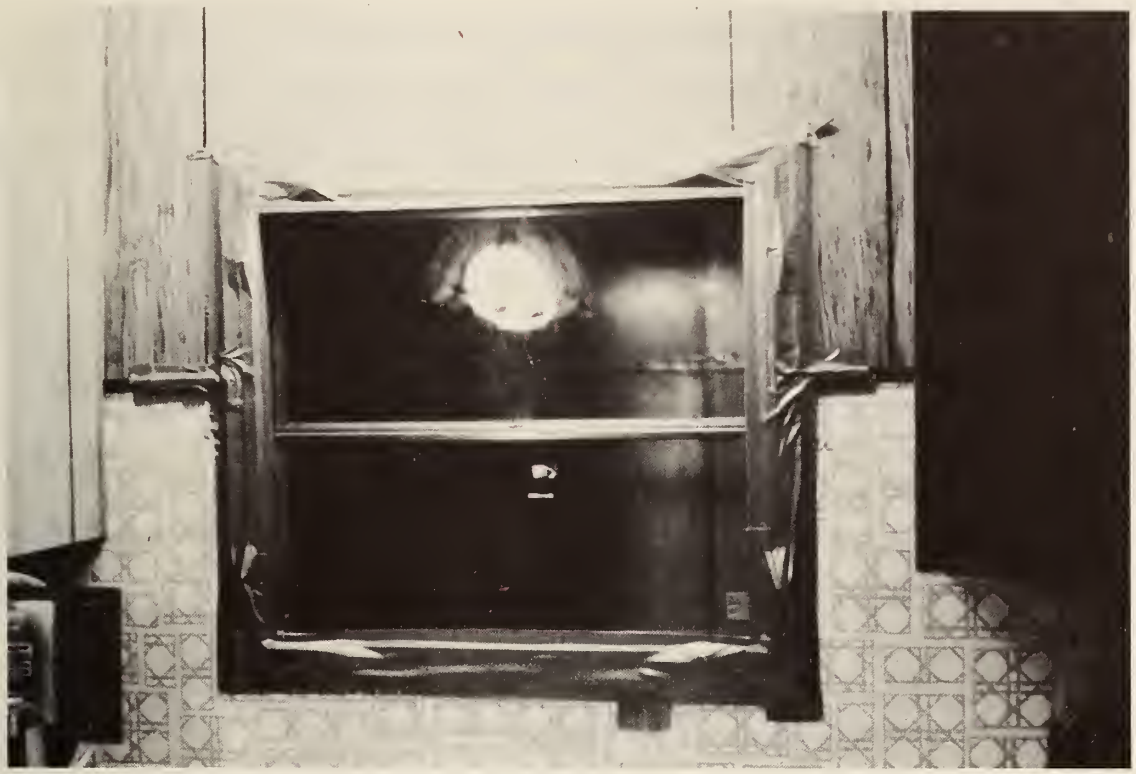
Figure 56 . Inside storm window sealed to wall surface.
